Restoring dammed rivers using artificial floods

March 29, 2022 | Gabriele Consoli, Rudolf M. Haller, Michael Doering, Saman Hashemi, Christopher Robinson

Spöl river catchment as a case study

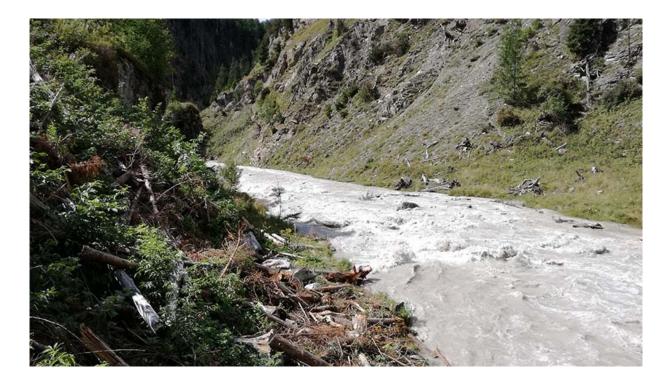
Cover Picture: An artificial flood on the Spöl River. (Photo: Gabriele Consoli, Eawag)

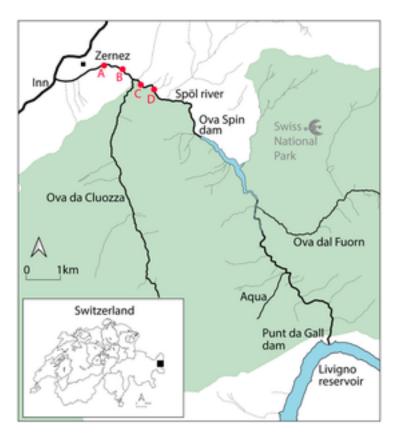
Figure 1. Location of the study area, Punt da Gall and Ova Spin dams. A-D indicate the location of sampling sites for before/after and during each flood. A, B are located below the junction with the tributary (Ova da Cluozza); C, D are located above. Site D and site A mark the boundaries of the drone flights. (Figure: Elsevier /

doi.org/10.1016/j.jenvman.2021.114122)

The Spöl catchment arises in the Central Alps and forms part of the Danube basin (Figure 1). Two large dams (Punt da Gall and Ova Spin) were built between 1960 and 1970 for electricity production, regulating the flow of the Spöl. The freely flowing Ova da Cluozza joins the Spöl mid-way between the Ova Spin dam and the river's junction with the Inn River near Zernez. The Ova da Cluozza's water levels vary substantially by season, including low winter flows and periodic rainfall or snowmelt-generated floods, reminiscent of the Spöl prior to dam construction.

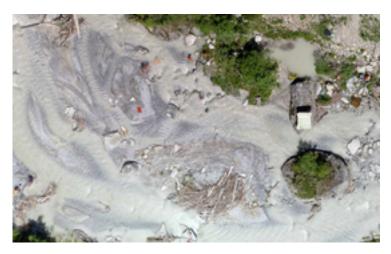
Figure 2. Aerial image of the Spöl River at its confluence with the Ova da Cluozza, 19 July 2019. Geomorphologists can be seen in orange jackets carrying out a sediment transport study. (Photo: Swiss National Park)

conditions (above tributary) and one, more dynamic, disturbed by periodic natural floods (below tributary). Each flood lasted eight hours, with a peak flow of 25 cubic metres per second for around two hours. We sampled various aspects of water quality, riverbed sediments, organic matter and aquatic insects (macroinvertebrates) before, during and after the floods. We also carried out drone surveys of the river, taking high resolution images that we used to assess any changes in the river's morphology (Figure 2).

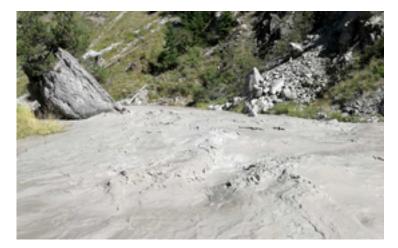
Figure 3. Highly turbid water during the artificial flood at site D, 4 September 2018.

We saw an immediate increase in river turbidity as the flow levels rose. The water was so turbid that it exceeded the detection limits of our field instruments (Figure 3). This was because the artificial floods mobilised sediment in the reservoir as well as on the riverbed. Total phosphorus and total nitrogen levels associated with the sediments were also elevated. At the same time, our sampling showed that the amount of transported organic matter and the number of insects and other macroinvertebrates entrained in the flow was markedly elevated.

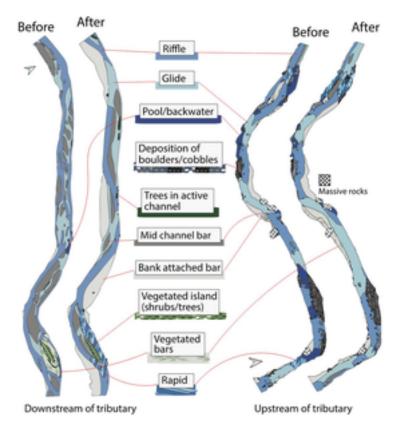
Figure 4. Predominant eco-morphological features before and after the artificial floods. (Figure: Elsevier / doi.org/10.1016/j.jenvman.2021.114122)

Our drone surveys showed that the river's morphology mostly changed downstream of the tributary after the artificial floods (Figure 4). The channel upstream of the tributary is narrow and shows signs of sediment depletion with vegetated sediment deposits (bars) detached from the stream, as is typical of a regulated river. The downstream section benefits from the free-flowing Ova da Cluozza carrying sediment and debris, which allow for much more dynamic changes in river morphology in response to artificial floods.

Sediments were redistributed and bars in the channel grew larger after the floods. The floods promoted lateral movement of the river and the enhancement of river morphology. The involvement of riparian vegetation resulted in the formation of valuable habitats within the floodplain, as normally seen in rivers unaffected by dams.
